## Inspection Report / Inspection: 1

| Date<br><b>19.01.2010</b> | P/O. No. | Weather | Surveyor's Name<br><b>Stanley Miller</b> | Pipe Segment Reference | Section No.<br><b>8</b> |

| Street<br><b>123</b> | <b>17th Street</b> | Use of Sewer | Upstream MH<br><b>1_ST17</b> |

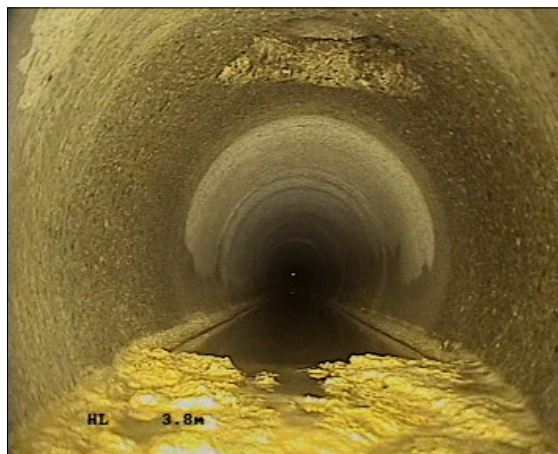
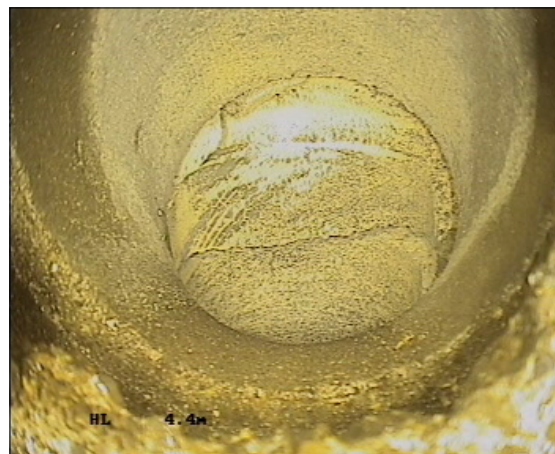
| 1:270 | Position | Code | Observation | Photo |
|---|---|---|---|---|
| | 11.40 | TBA | Tap Break-In Active, at 12 o'clock, 5", within 8 inches of joint: YES | 8_2A, b |

Photo: 8\_2A, Media No.: 010208\_1, 00:00:00  
 11.4FT, Tap Break-In Active, at 12 o'clock, 5", within 8 inches of joint: YES

Photo: 8\_2B, Media No.: 010208\_1, 00:00:00  
 11.4FT, Tap Break-In Active, at 12 o'clock, 5", within 8 inches of joint: YES

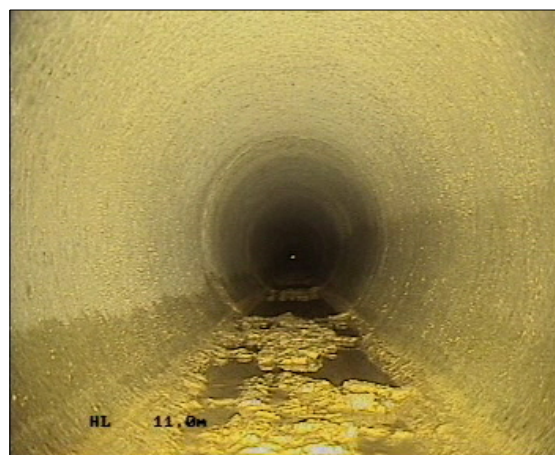
| 1:270 | Position | Code | Observation | Photo |
|---|---|---|---|---|
| | 33.00 | DSZ | Deposits Settled Other, 5 %of cross sectional area, from 05 to 07 o'clock, , within 8 inches of joint: NO / deposits SOFT | 8_4A |

Photo: 8\_4A, Media No.: 010208\_1, 00:03:27  
 33FT, Deposits Settled Other, 5 %of cross sectional area, from 05 to 07 o'clock, , within 8 inches of joint: NO / deposits SOFT

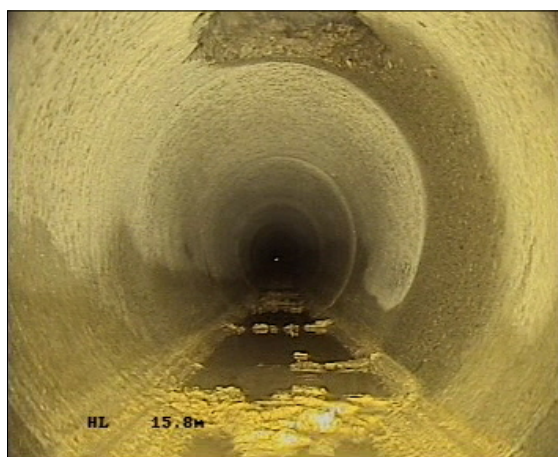
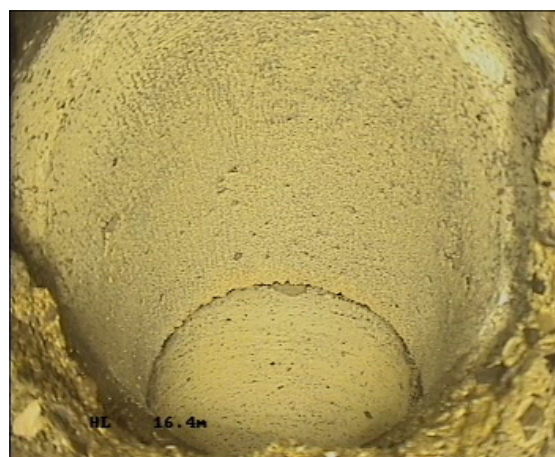
| 1:270 | Position | Code | Observation | Photo |
|---|---|---|---|---|
| | 48.00 | TBA | Tap Break-In Active, at 12 o'clock, 5", within 8 inches of joint: YES | 8_5A, b |

Photo: 8\_5A, Media No.: 010208\_1, 00:04:20  
 48FT, Tap Break-In Active, at 12 o'clock, 5", within 8 inches of joint: YES

Photo: 8\_5B, Media No.: 010208\_1, 00:04:20  
 48FT, Tap Break-In Active, at 12 o'clock, 5", within 8 inches of joint: YES

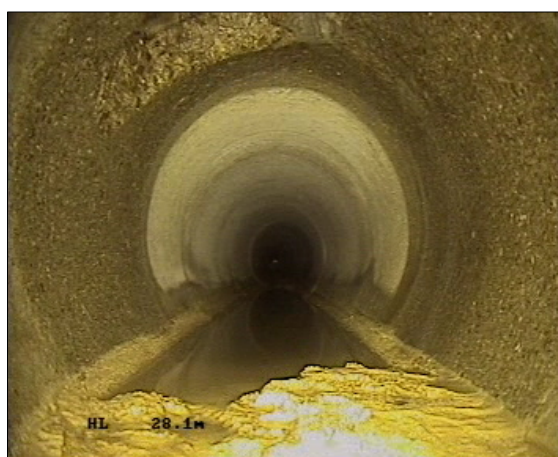
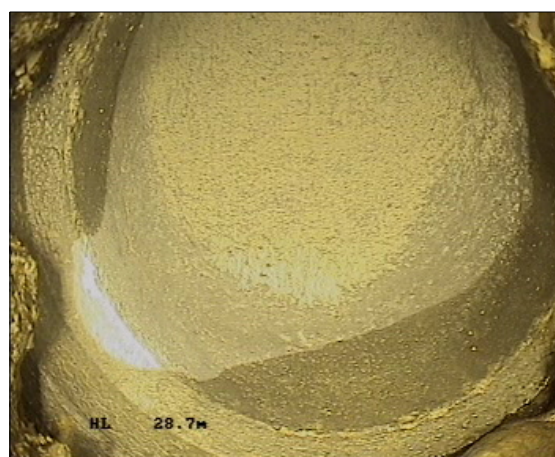
| 1:270 | Position | Code | Observation | Photo |
|---|---|---|---|---|
| | 85.50 | TBA | Tap Break-In Active, at 11 o'clock, 5", within 8 inches of joint: YES | 8_6A, b |

Photo: 8\_6A, Media No.: 010208\_1, 00:07:46  
 85.5FT, Tap Break-In Active, at 11 o'clock, 5", within 8 inches of joint: YES

Photo: 8\_6B, Media No.: 010208\_1, 00:07:46  
 85.5FT, Tap Break-In Active, at 11 o'clock, 5", within 8 inches of joint: YES

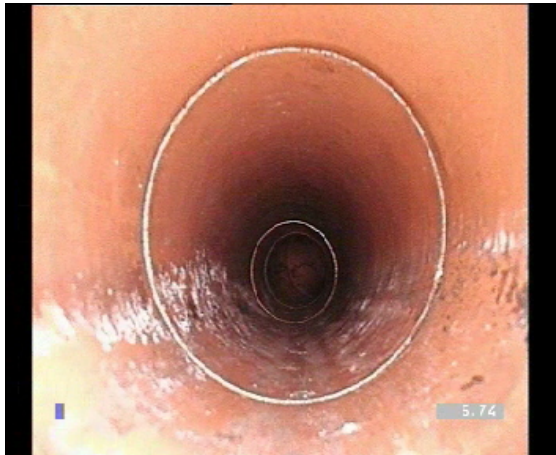
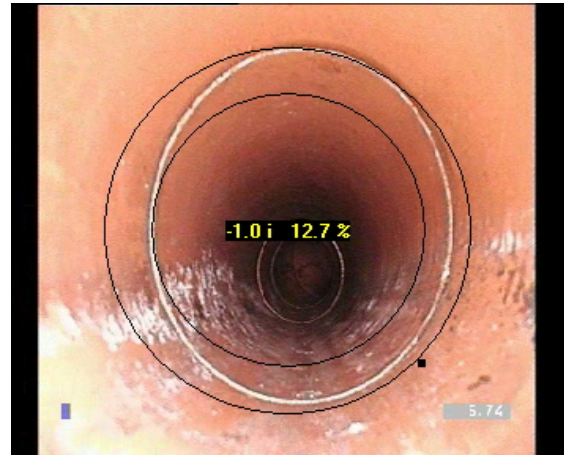
| 1:75 | Position | Code | Observation | Photo |
|---|---|---|---|---|
| | 17.00 | D | Deformed, 10 % | 4_2A, b |

Photo: 4\_2A, VCR No.: 010208\_1  
 17FT, Deformed, 10 %

Photo: 4\_2B, VCR No.: 010208\_1  
 17FT, Deformed, 10 %

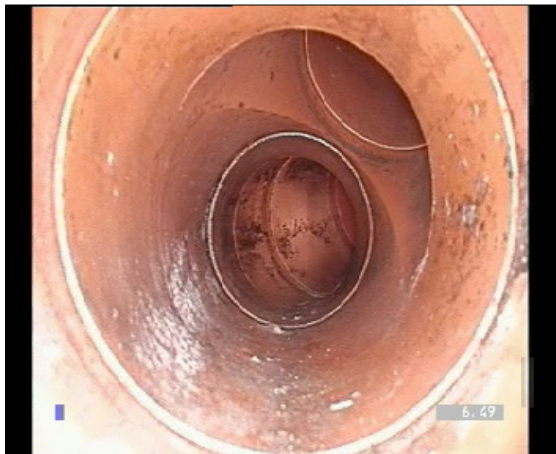
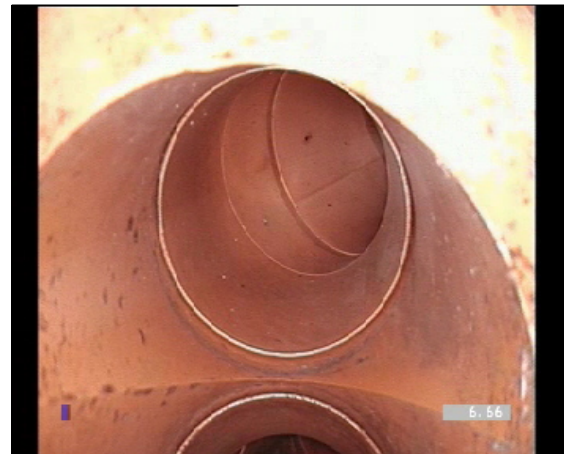
| 1:75 | Position | Code | Observation | Photo |
|---|---|---|---|---|
| | 20.00 | TS | Tap Saddle, at 02 o'clock, 5", within 8 inches of joint: NO | 4_3A, b |

Photo: 4\_3A, VCR No.: 010208\_1  
 20FT, Tap Saddle, at 02 o'clock, 5", within 8 inches of joint: NO

Photo: 4\_3B, VCR No.: 010208\_1  
 20FT, Tap Saddle, at 02 o'clock, 5", within 8 inches of joint: NO

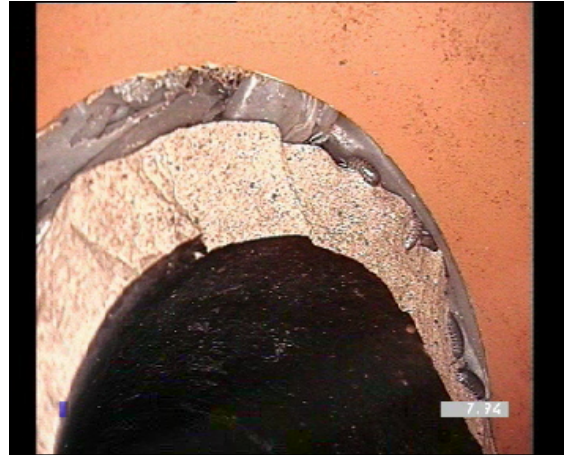
| 1:75 | Position | Code | Observation | Photo |
|---|---|---|---|---|
| | 24.00 | VZ | Vermine Other, quantity: 2 cm, within 8 inches of joint: NO / cannot be determined | 4_4A, b |

Photo: 4\_4A, VCR No.: 010208\_1  
 24FT, Vermin Other, quantity: 2 cm, within 8 inches of joint:  
 NO / cannot be determined

Photo: 4\_4B, VCR No.: 010208\_1  
 24FT, Vermin Other, quantity: 2 cm, within 8 inches of joint:  
 NO / cannot be determined

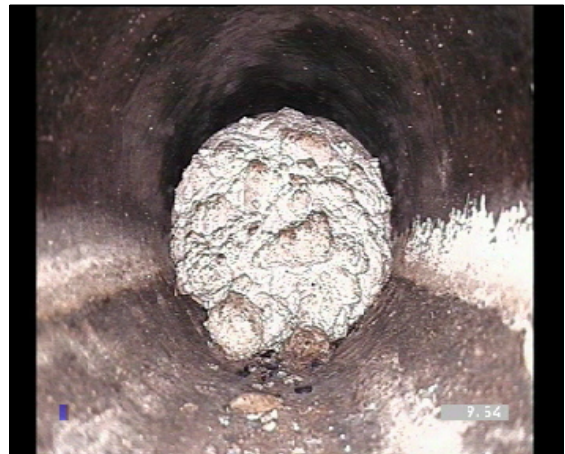
| 1:75 | Position | Code | Observation | Photo |
|---|---|---|---|---|
| | 30.00 | OBZ | Obstacles Other, 100 % of cross sectional area, from 12 to 12 o'clock | 4_6A, b |

Photo: 4\_6A, VCR No.: 010208\_1  
 30FT, Obstacles Other, 100 %of cross sectional area, from  
 12 to 12 o'clock

Photo: 4\_6B, VCR No.: 010208\_1  
 30FT, Obstacles Other, 100 %of cross sectional area, from  
 12 to 12 o'clock

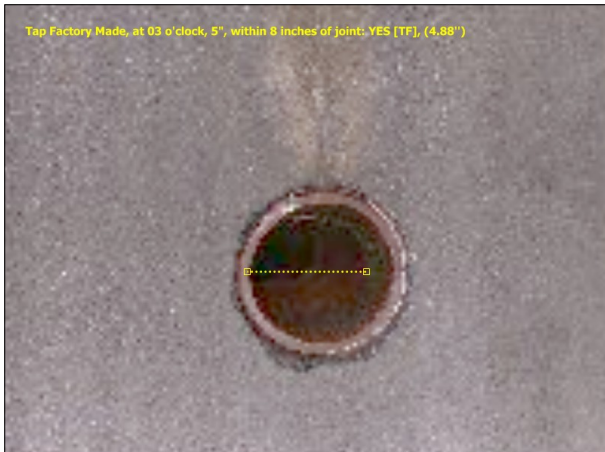
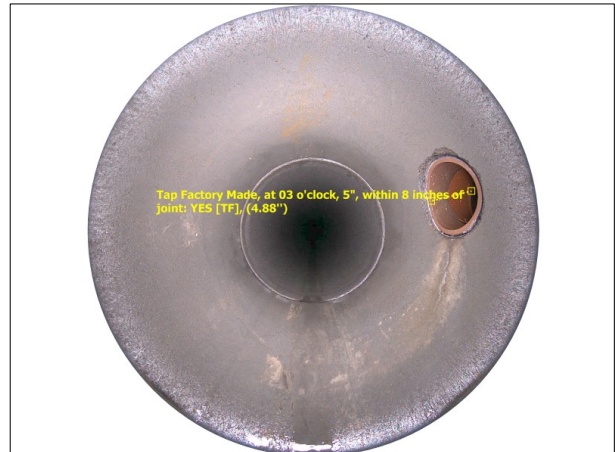
Photo: 7\_3A, Media No.: 010208\_1  
 90.59FT, Tap Factory Made, at 03 o'clock, 5", within 8 inches of joint: YES

Photo: 7\_3B, Media No.: 010208\_1  
 90.59FT, Tap Factory Made, at 03 o'clock, 5", within 8 inches of joint: YES

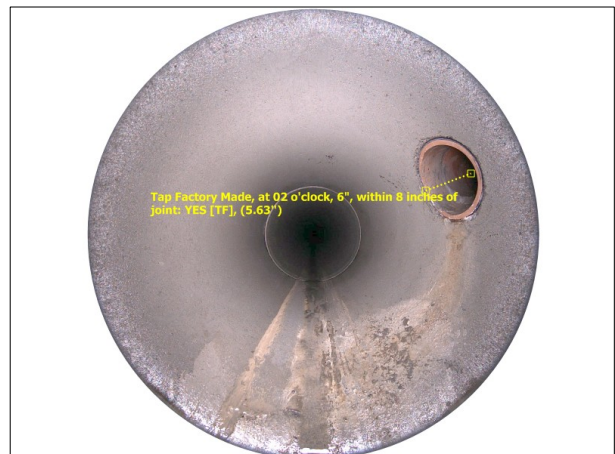
Photo: 7\_4A, Media No.: 010208\_1  
 105.97FT, Tap Factory Made, at 02 o'clock, 6", within 8 inches of joint: YES

Photo: 7\_4B, Media No.: 010208\_1  
 105.97FT, Tap Factory Made, at 02 o'clock, 6", within 8 inches of joint: YES

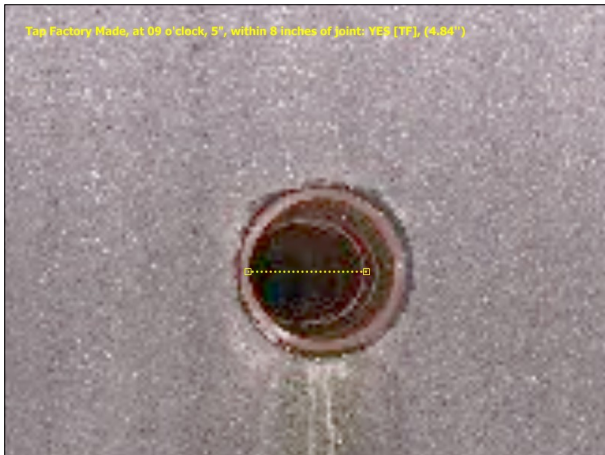
Photo: 7\_5A, Media No.: 010208\_1  
 134.91FT, Tap Factory Made, at 09 o'clock, 5", within 8 inches of joint: YES

Photo: 7\_5B, Media No.: 010208\_1  
 134.91FT, Tap Factory Made, at 09 o'clock, 5", within 8 inches of joint: YES

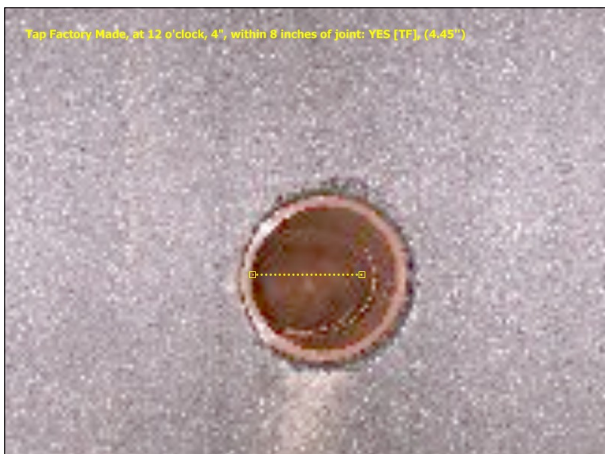
Photo: 7\_6A, Media No.: 010208\_1  
 136.98FT, Tap Factory Made, at 12 o'clock, 4", within 8 inches of joint: YES

Photo: 7\_6B, Media No.: 010208\_1  
 136.98FT, Tap Factory Made, at 12 o'clock, 4", within 8 inches of joint: YES

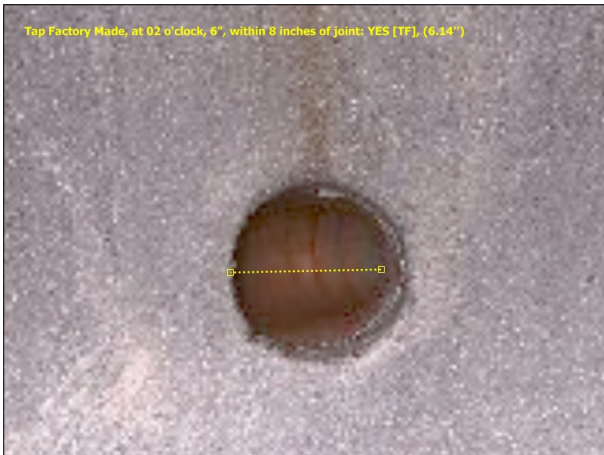
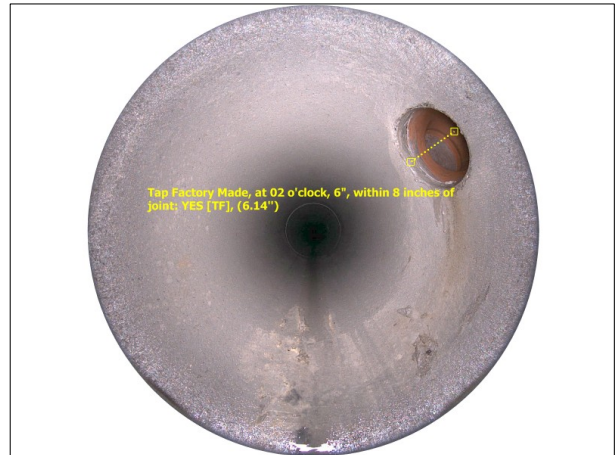
Photo: 7\_7A, Media No.: 010208\_1  
 177.99FT, Tap Factory Made, at 02 o'clock, 6", within 8 inches of joint: YES

Photo: 7\_7B, Media No.: 010208\_1  
 177.99FT, Tap Factory Made, at 02 o'clock, 6", within 8 inches of joint: YES

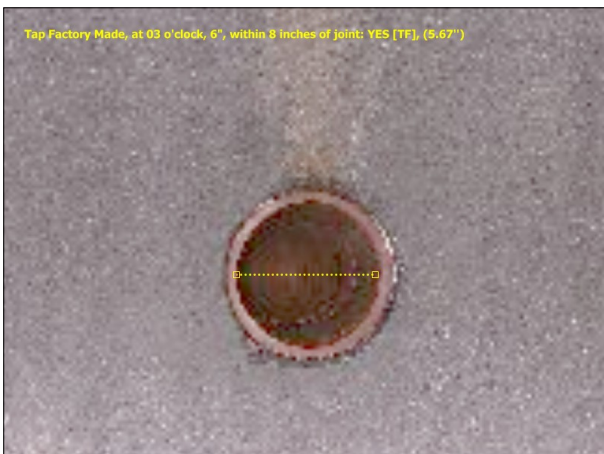
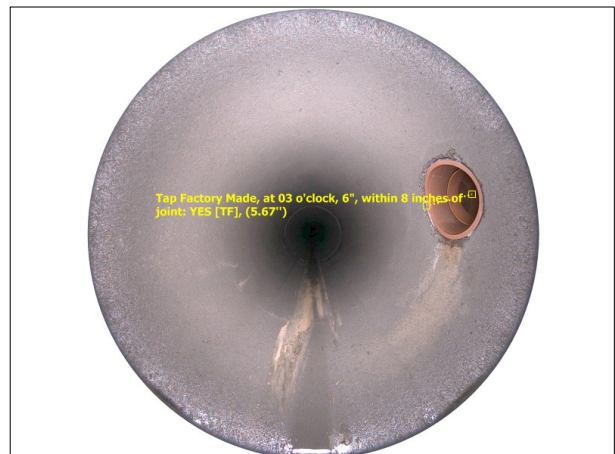
Photo: 7\_8A, Media No.: 010208\_1  
 186.42FT, Tap Factory Made, at 03 o'clock, 6", within 8 inches of joint: YES

Photo: 7\_8B, Media No.: 010208\_1  
 186.42FT, Tap Factory Made, at 03 o'clock, 6", within 8 inches of joint: YES

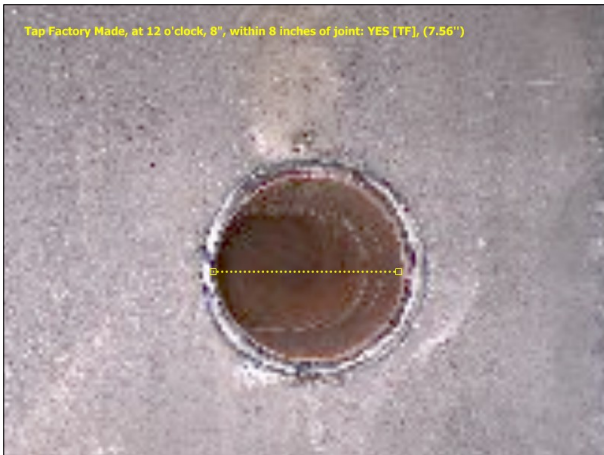
Photo: 7\_9A, Media No.: 010208\_1  
 238.89FT, Tap Factory Made, at 12 o'clock, 8", within 8 inches of joint: YES

Photo: 7\_9B, Media No.: 010208\_1  
 238.89FT, Tap Factory Made, at 12 o'clock, 8", within 8 inches of joint: YES

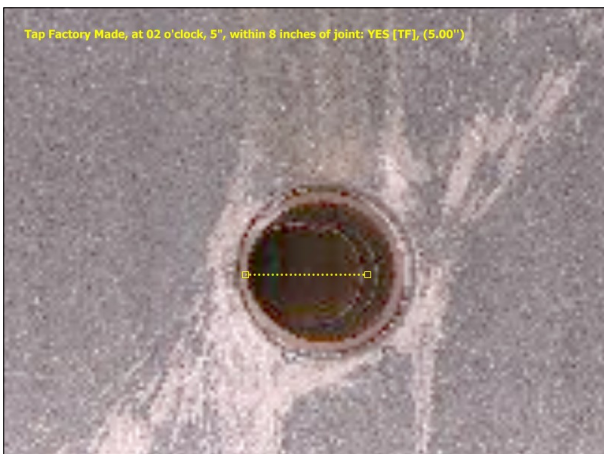
Photo: 7\_10A, Media No.: 010208\_1  
 244.04FT, Tap Factory Made, at 02 o'clock, 5", within 8 inches of joint: YES

Photo: 7\_10B, Media No.: 010208\_1  
 244.04FT, Tap Factory Made, at 02 o'clock, 5", within 8 inches of joint: YES
